VAN BUREN COUNTY
JOE PARMAN, DRAIN COMMISSIONER

DAM INSPECTION REPORTS

APRIL, 2011

PROJECT NO. 9527-6

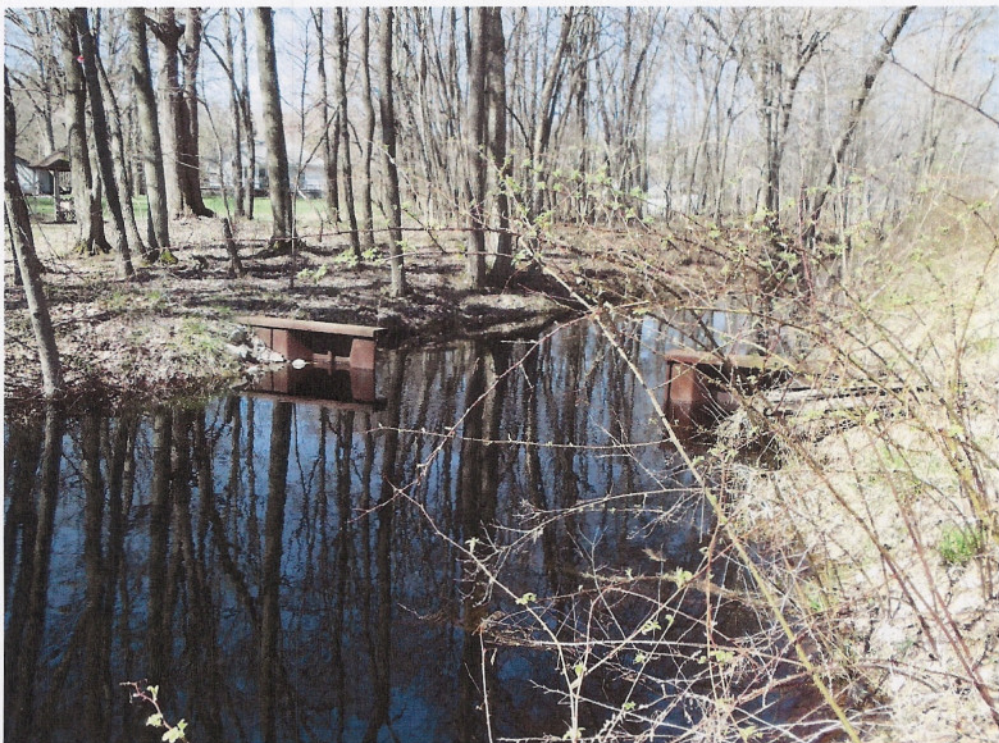
OUTLET CHANNEL

The county drain south of Brandywine Road may need cleaning.

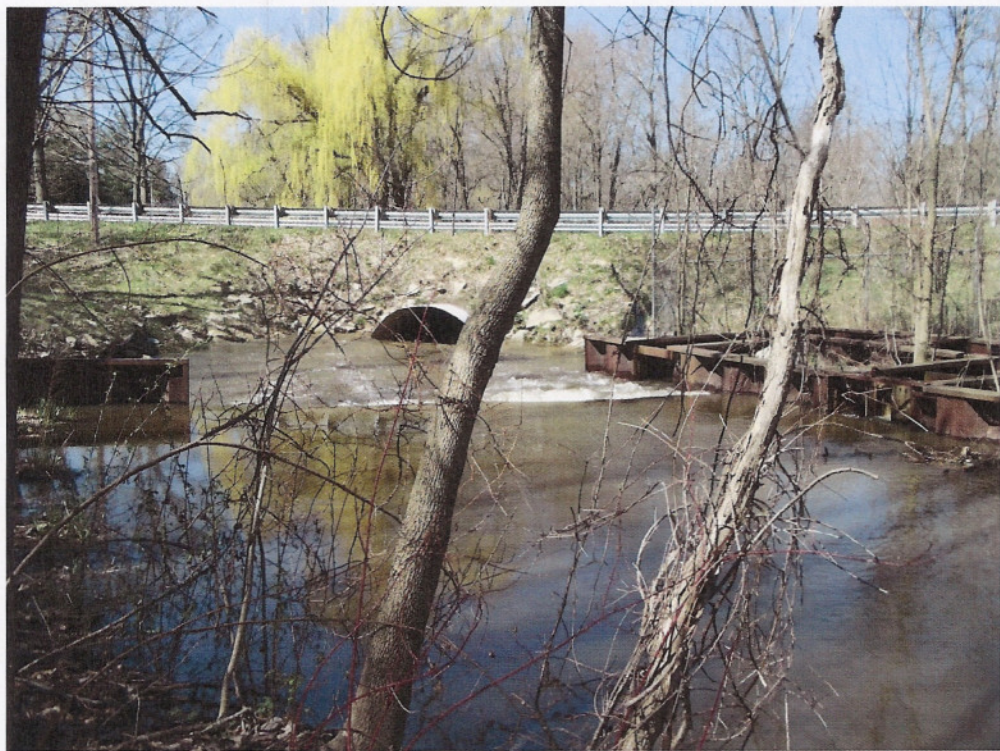
CONTROL STRUCTURE AND INLET CHANNEL

The area inside the fenced area is overgrown with brush and trees. These should be removed and stumps should be treated with herbicide.

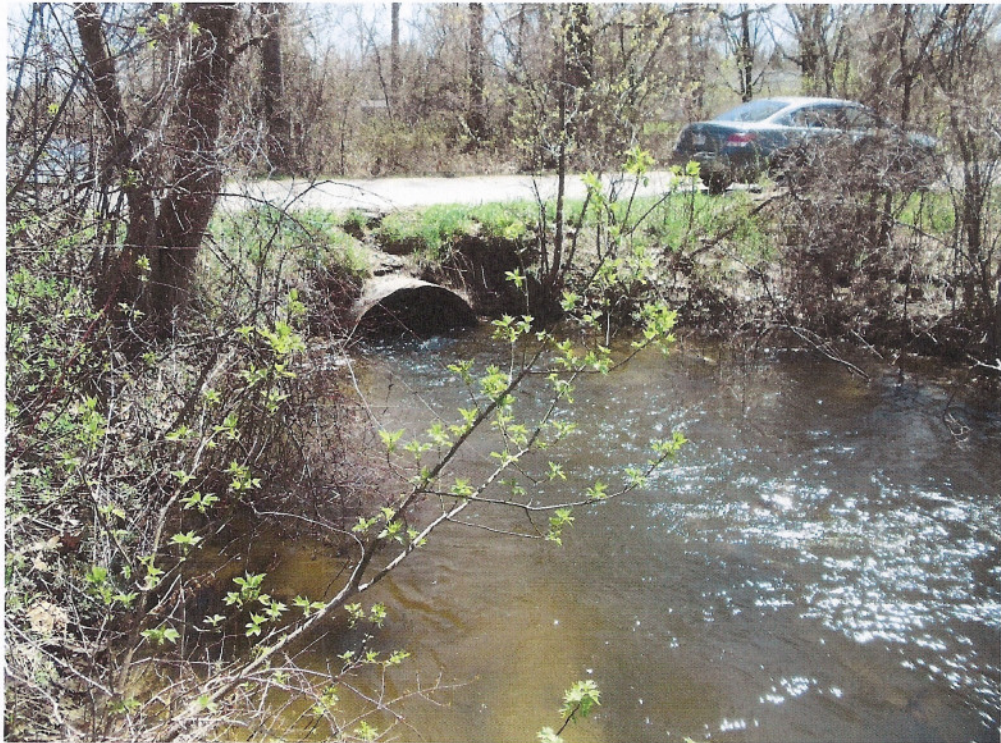
CONTROL STRUCTURE AND OUTLET PIPE

There is some erosion at the outlet pipe. Fill and riprap are needed to stabilize the embankment.

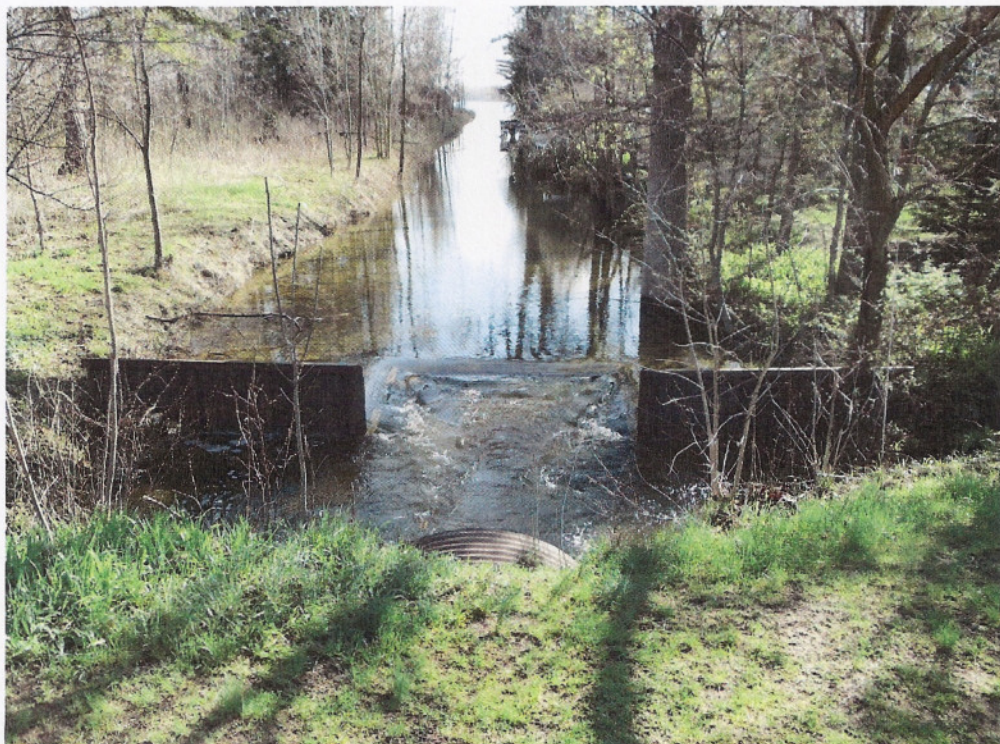
CONTROL STRUCTURE AND INLET CHANNEL

Both steel sheeting wingwalls are developing holes from corrosion. Consideration should be given to repair or replacement of the structure. Trees and brush growing adjacent to the wingwalls should be removed.
